# Swivel-eyed

*Neglect regular greasing and the 2CV's kingpins will wear. Tony Stuart-Jones looks at the cure*

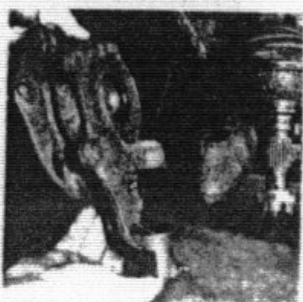
Once the nut has been undone, the driveshaft can be compressed and withdrawn from the rear of the swivel assembly.

Having removed the nut, the splined end of the driveshaft was gently tapped through the hub and the driveshaft withdrawn clear of the hub and swivel assembly. As the driveshaft is of the sliding type, its length can be compressed so the outer splined end just clears the inboard part of the hub assembly. This avoids having to disconnect the driveshaft at the inner brake drum end.

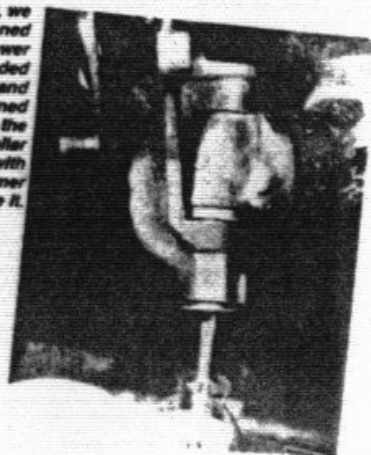
Finally, we tightened the lower threaded plug and turned down the collar flange with a hammer to secure it.

At the bottom end, we screwed in the new plug until the collar was touching the hub flange, and locked the plug by tapping down the collar at four points around the edge.
